# San Fernando, California, Earthquake of February 9, 1971

U.S. DEPARTMENT OF COMMERCE  
National Oceanic and Atmospheric Administration

*Part B. Buildings continued; Soils and Foundations*

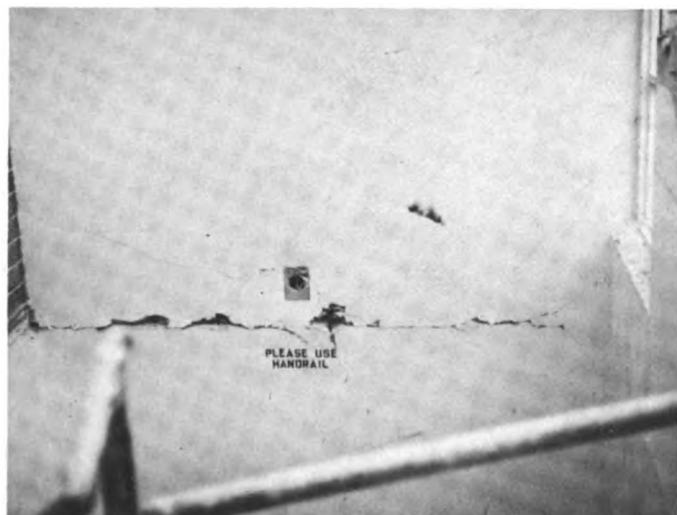
The concrete stair wall at the east end of stair No. 1 (fig. 3) was cracked badly. The worst cracks were located at the horizontal construction joints shown in figure 18. Stair landing beams were damaged. The grouted brick north wall of this stair had several diagonal cracks at the second level. The south concrete walls were not damaged. The east-end wall on line 17 was undamaged.

Figure 18.—Pacoima Memorial Lutheran Hospital. East wall of stair No. 1. Horizontal movement is at second-floor construction joint. Paul Fratessa photograph.

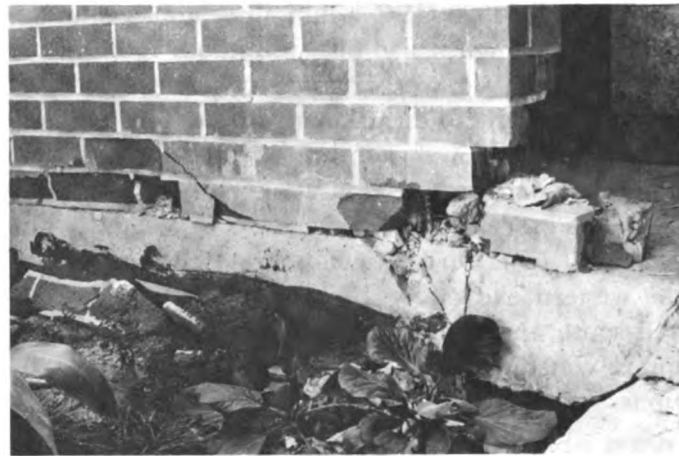
The second level, where the main entrance is located, was damaged very severely. The floor slab at the entrance (near B-7) was cracked (fig. 8). The grouted brick shear wall between lines A and B, 12 feet 11 inches west of line 7, shattered along the base and moved about  $\frac{1}{2}$  inch to the south (fig. 19). The concrete wall north of the entrance (line B near line 7) suffered small diagonal cracks throughout. The concrete wall on line D at the west end of the unit was not damaged. The interior concrete block walls at the stairs and electrical closet near lines B and 7 were shattered badly. When these walls were removed, it was found that there were no dowels from slab to block wall as are customarily used. The concrete column at A-7 (fig. 20) and the adjoining two columns to the east were cracked. Evidently, this was due to north-south motion. The concrete at the column at C-7 was spalled badly. No damage was observed at other columns. The grouted brick shear wall 6 feet 1 inch east of line 15 was not damaged.

It is evident that the rigid unit above the second level rotated about the more rigid east grouted-brick shear wall. There was insufficient strength in the three small shear walls near line 7 to resist the shear and torsional forces. The grouted brick wall at the

Figure 19.—Pacoima Memorial Lutheran Hospital. Grouted brick wall 12 feet 11 inches west of line 7, looking east. J. F. Meehan photograph.

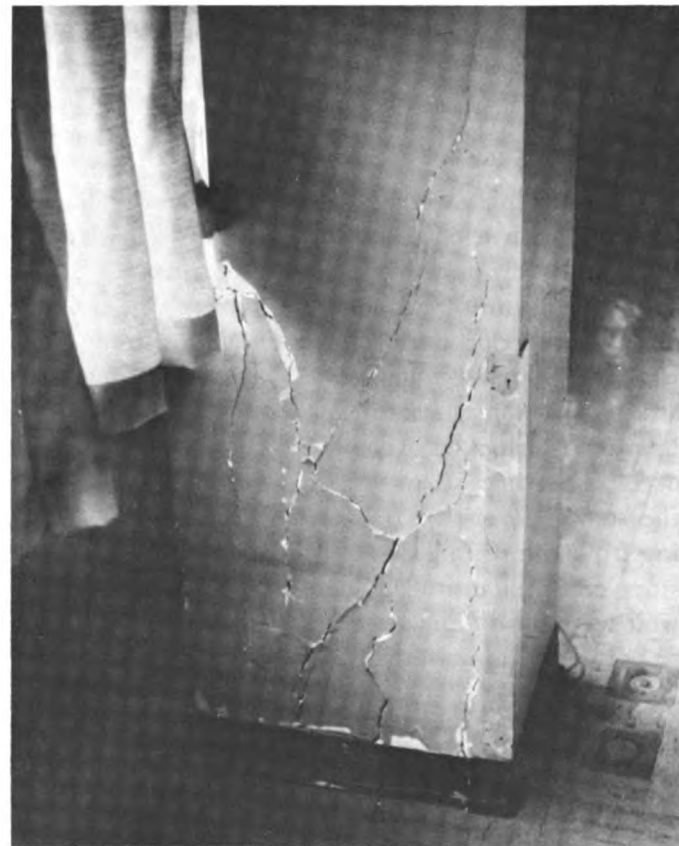
Figure 20.—Pacoima Memorial Lutheran Hospital. Column A-7 above second level; cracking is in plaster. Cracks in concrete were in same pattern. Paul Fratessa photograph.

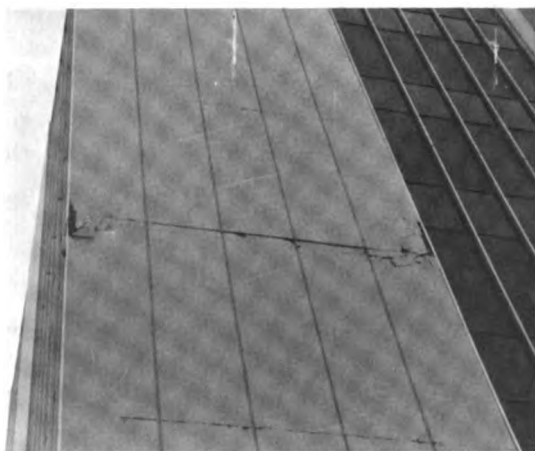
Figure 10.—Indian Hills Medical Center.  
North-side shear wall, east end.

Some of the shear walls were damaged by cracks at the horizontal construction joints at floorlines (figs. 10 and 11). There is evidence of slight horizontal movement. These cracks are not related directly to shear as a measure of diagonal tension. The slab depth is 6½ inches thick, and, in some cases, cracks occurred at the top and bottom of this intrusion of 3,000 psi lightweight concrete into the higher strength rock concrete of the shear walls proper.

The ends of the shear walls were designed as columns and were subjected to shear and axial load stresses. Concrete in the splice area crumbled (fig. 11). All of the shear walls in the lower levels cracked in the typical X-pattern (figs. 10 through 14), indicating high shear stresses.

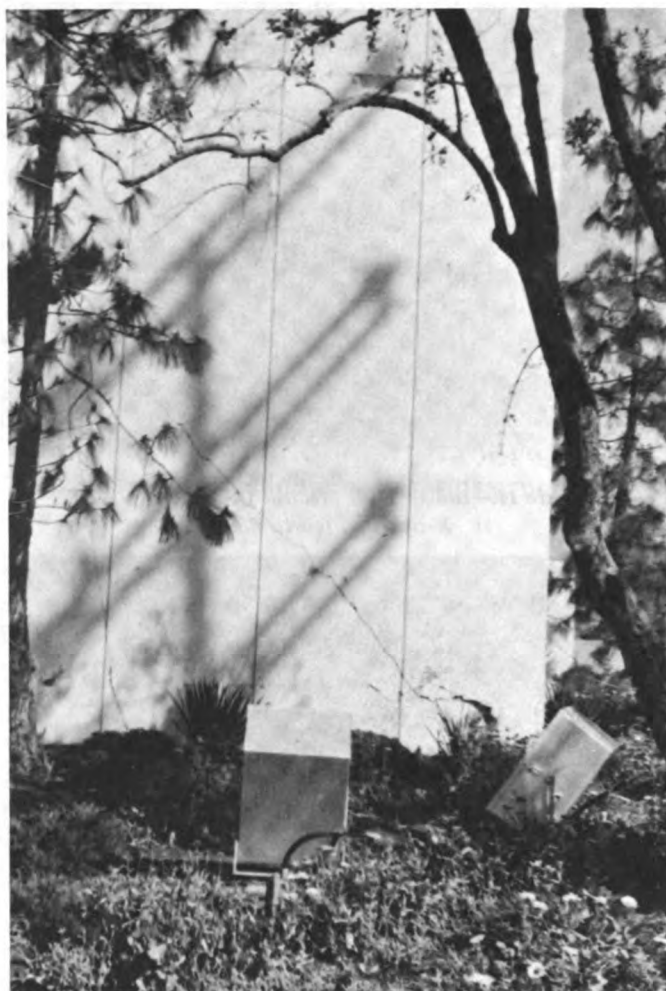
Figure 12.—Indian Hills Medical Center.  
South-side shear wall, east end.

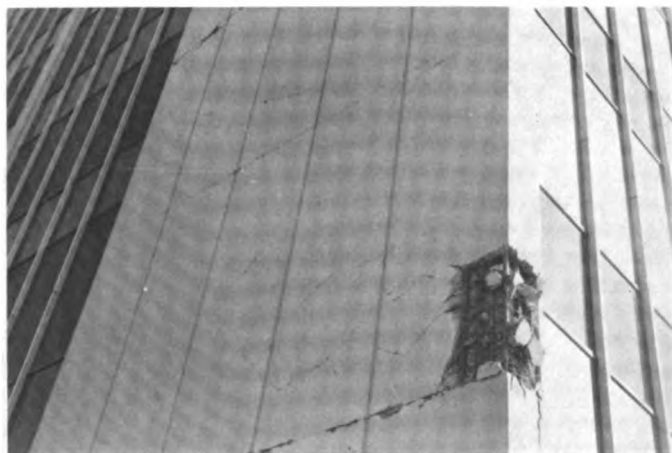
Figure 11.—Indian Hills Medical Center.  
North-side shear wall, west end.

3 Spalling and crushing occurred in lap-splice areas of vertical rebars in columns. Special ties at these locations should be considered. The whole question of confinement of concrete by ties at compression and tension splices needs further study. Similarly, damage to boundary elements of shear walls in tension casts some question on the lap-splice criteria used, particularly where seismic forces are to be resisted. Does confinement offer the practical solution to this? Perhaps boundary elements of shear walls, at least at splices, should have confining reinforcement similar to that now recommended for ductile columns, or possibly always should be designed as tension splices.

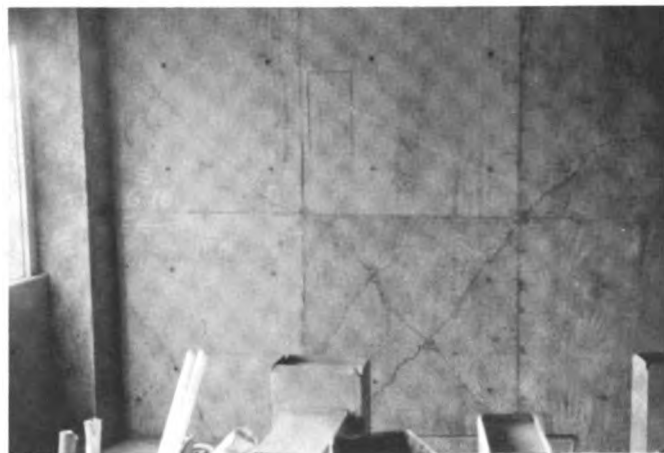
Figure 13.—Indian Hills Medical Center. Shear wall  
X-cracking, third floor.

The typical X-cracking in shear walls was in the east and west shear walls of the north elevation below the fifth floor, as well as in the center shear walls of the east and west elevations below the fifth floor. On the south elevation, diagonal X-cracks occurred only below the fourth floor. The X-cracking produced fairly uniform crack widths in both north-south and east-west walls. The location of this more pronounced X-cracking in the lower floors indicates that the building accelerations were, in general, in the first mode.

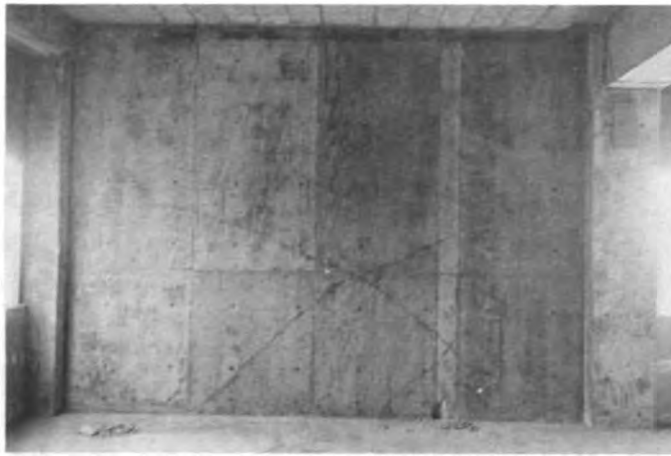
*Figure 14.—Indian Hills Medical Center. Shear wall X-cracking, fourth floor.*

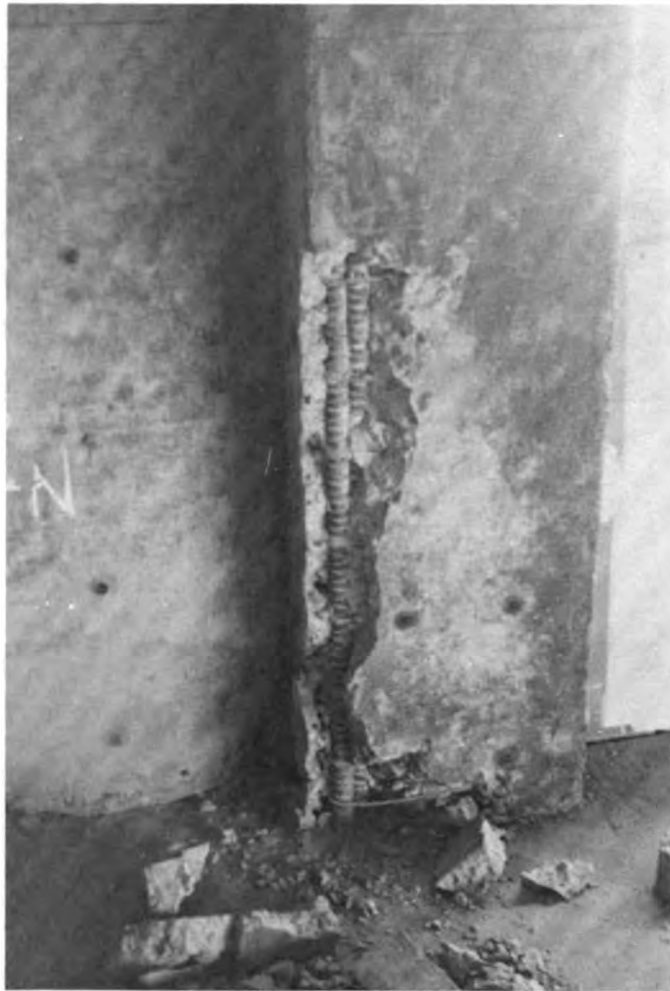
*Figure 15.—Indian Hills Medical Center. Third-floor exterior column damage.*

In several cases where shear walls were tied into the building proper by concrete girders having a significant moment of inertia, damage was noted at the intersection of girder and wall (figs. 15 and 16). The girders run in a north-south direction. Damage was noted where considerable restraint in bending was offered by the girders (fig. 17). However, in at least one case, damage was found in an interior column-girder connection (fig. 18). The 6½-inch-thick floor slab usually is considered a rather stiff diaphragm. Some yield or inelastic deformation must have occurred, either in the diaphragm and/or the walls, to allow the interior beam-column connection to become damaged. The distribution of this type of damage indicates that the failure of the splicing of shear wall end reinforcing was the principal reason for this inelastic deformation, even though there was some cracking in the floor slabs.

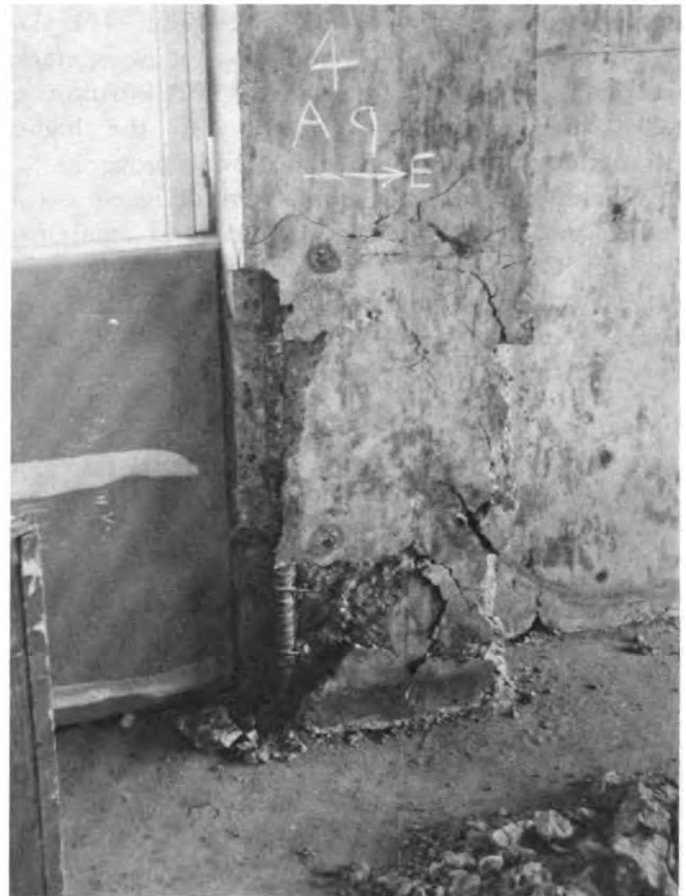
*Figure 16.—Indian Hills Medical Center. Fourth-floor exterior column damage.*

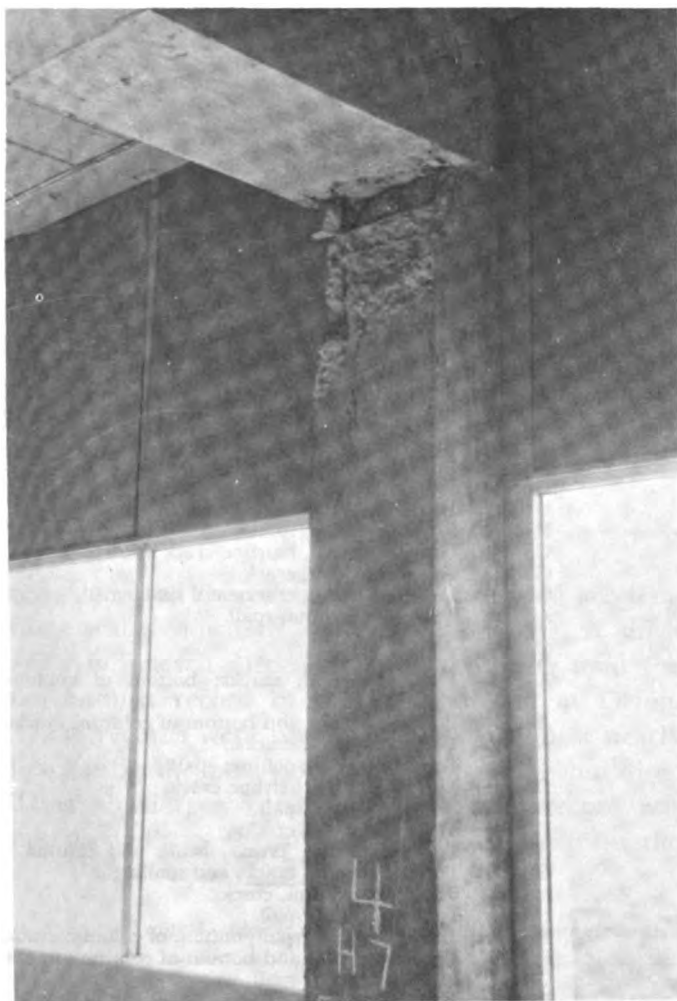
Figure 17.—Indian Hills Medical Center. Fourth-floor exterior girder and column damage.

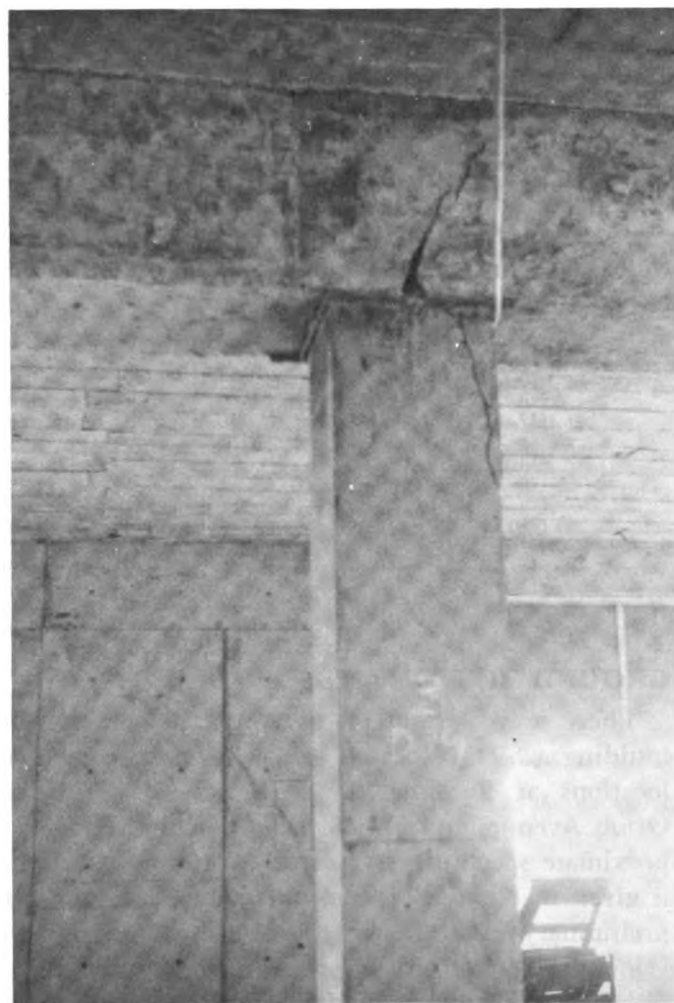
Figure 18.—Indian Hills Medical Center. Third-floor interior girder and column damage.

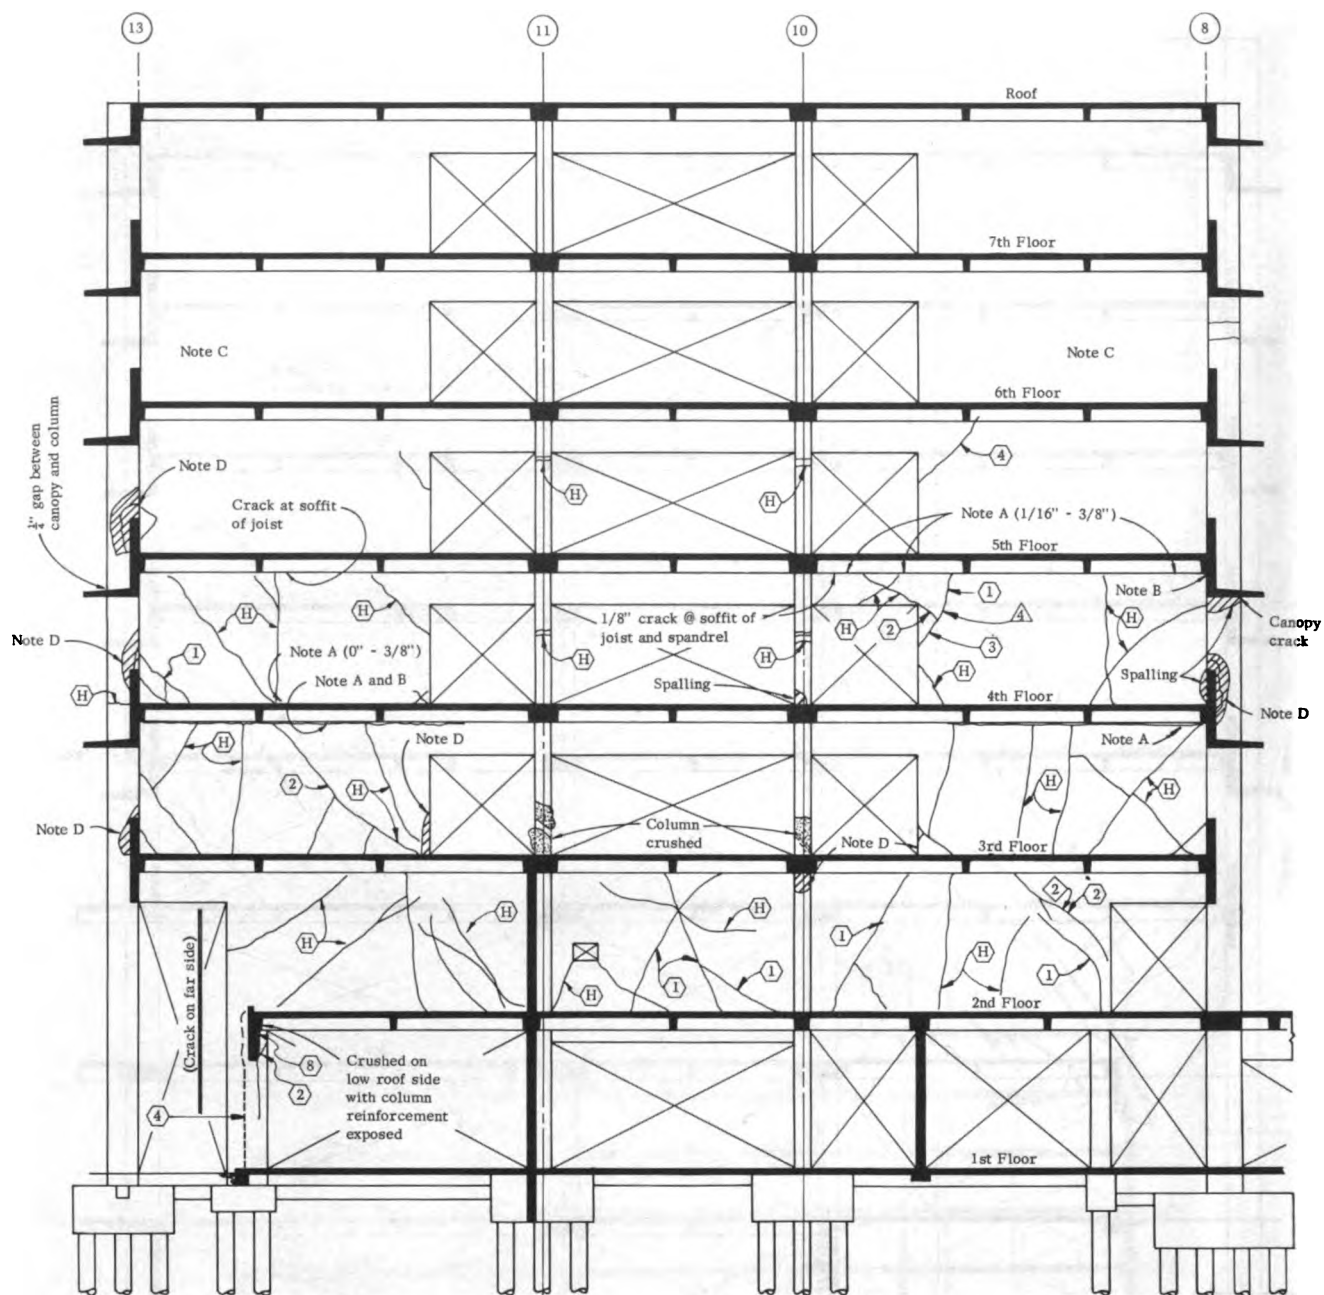
Figure 16.—Holy Cross Hospital. Section at grid line E (west wall, 7-story tower).

2 Each of the west shear wall elements exhibited a cracking of the lightweight floor pour intrusion at the third-floor level, permitting large rotations to the walls above the break (figs. 16 and 17).

7 Excessive nonelastic movement of the shear walls produced deformations large enough to cause portions of the vertical load framing system to act as a moment frame so that columns were carrying seismic shears and moments. Due to deformations in the transverse (north-south) direction, the columns exhibited shear cracking. This cracking was most severe in the second, third, and fourth stories, decreasing above the fourth level (figs. 2 and 22). In the longitudinal (east-west) direction, many of the exterior spandrels were crushed in flexural compression and the column cover was shattered, exposing the reinforcing (fig. 16). This was most noticeable on the third floor.

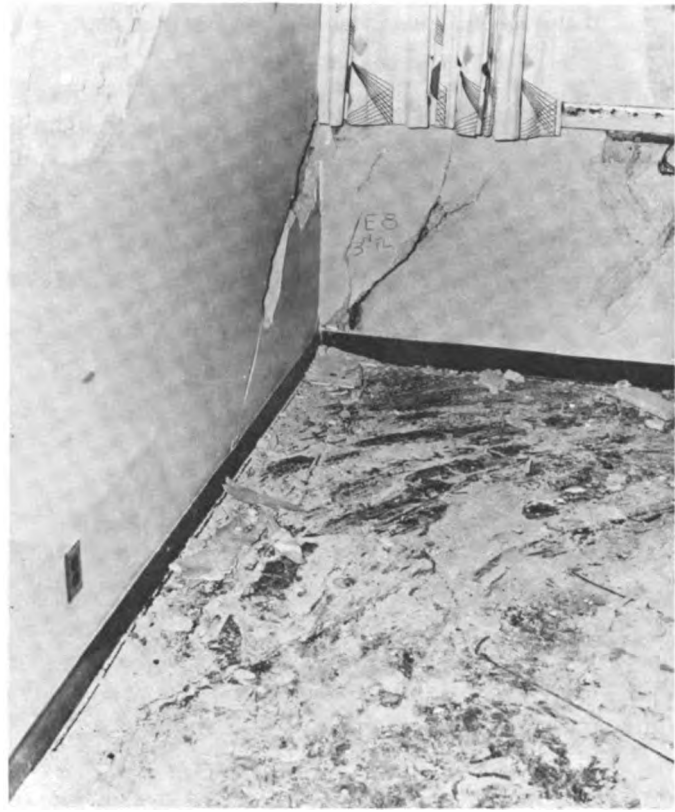
Figure 18.—Holy Cross Hospital. Diaphragm failure at west wall.

were inadequate to redistribute horizontal loads on the second, third, and fourth floors, and were damaged severely in this area as indicated by cracks extending across the full width of the building (fig. 18).

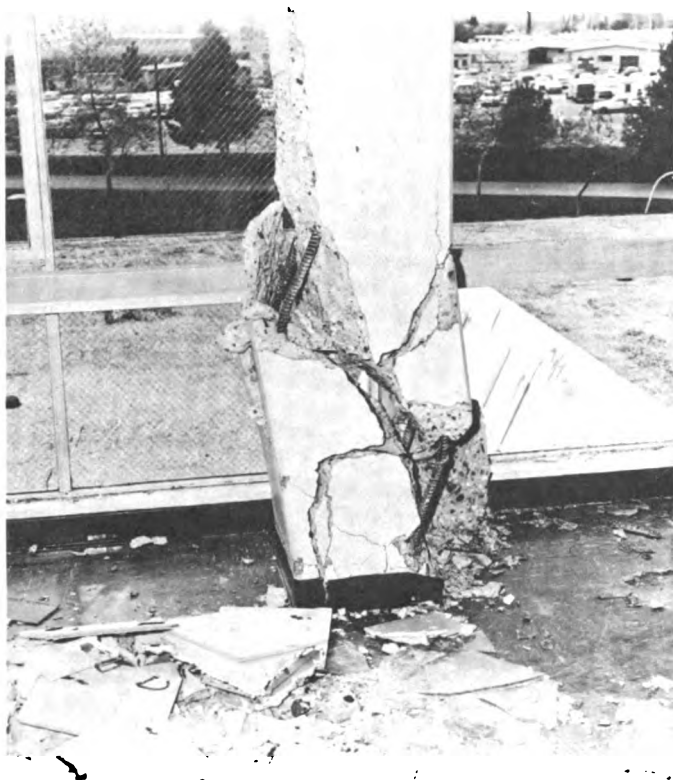
*Figure 19.—Holy Cross Hospital. Column failure at E-11 (third floor).*

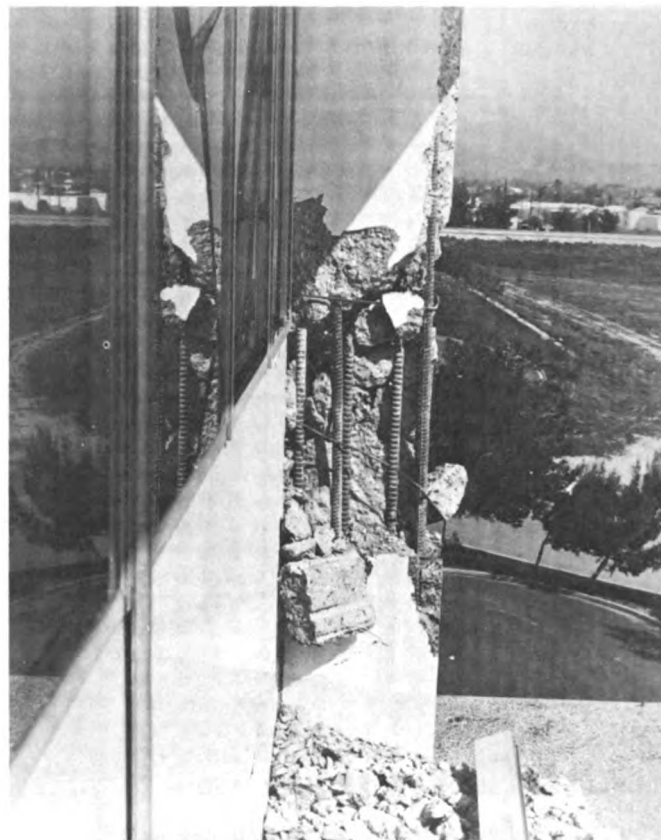
*Figure 21.—Holy Cross Hospital. Shear wall column, southeast corner.*

- 2 The failure in the east wall (figs. 20 and 21) indicates that a stagger or confinement of the lap splice of shear wall flexural reinforcement would assist in preserving this joint.

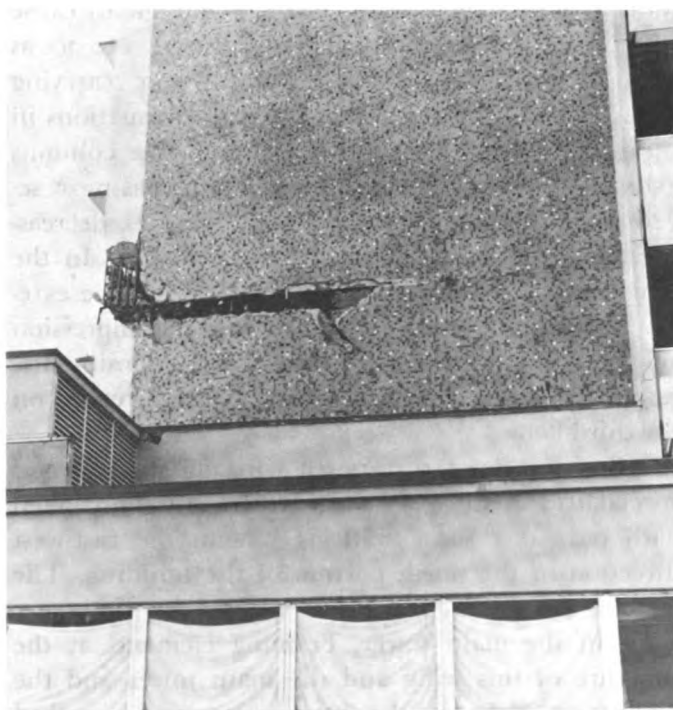
*Figure 20.—Holy Cross Hospital, east wall.*

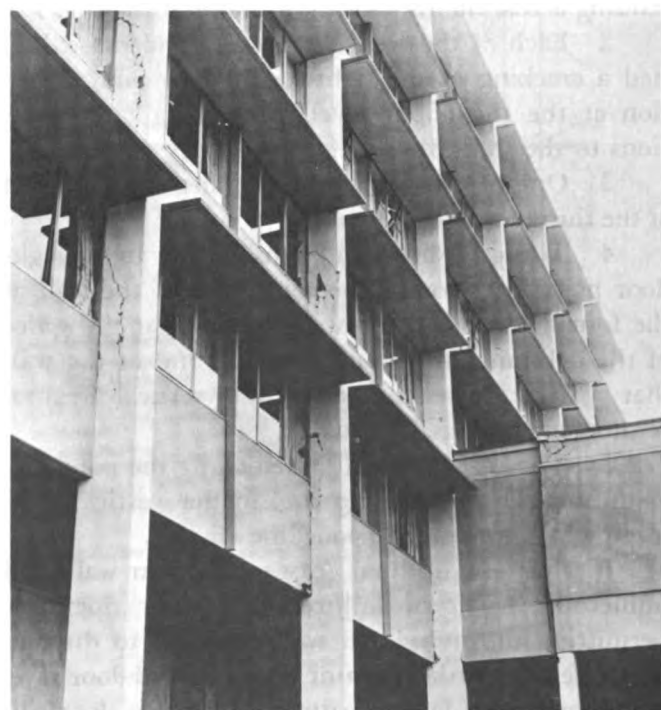
*Figure 22.—Holy Cross Hospital. North side of tower.*

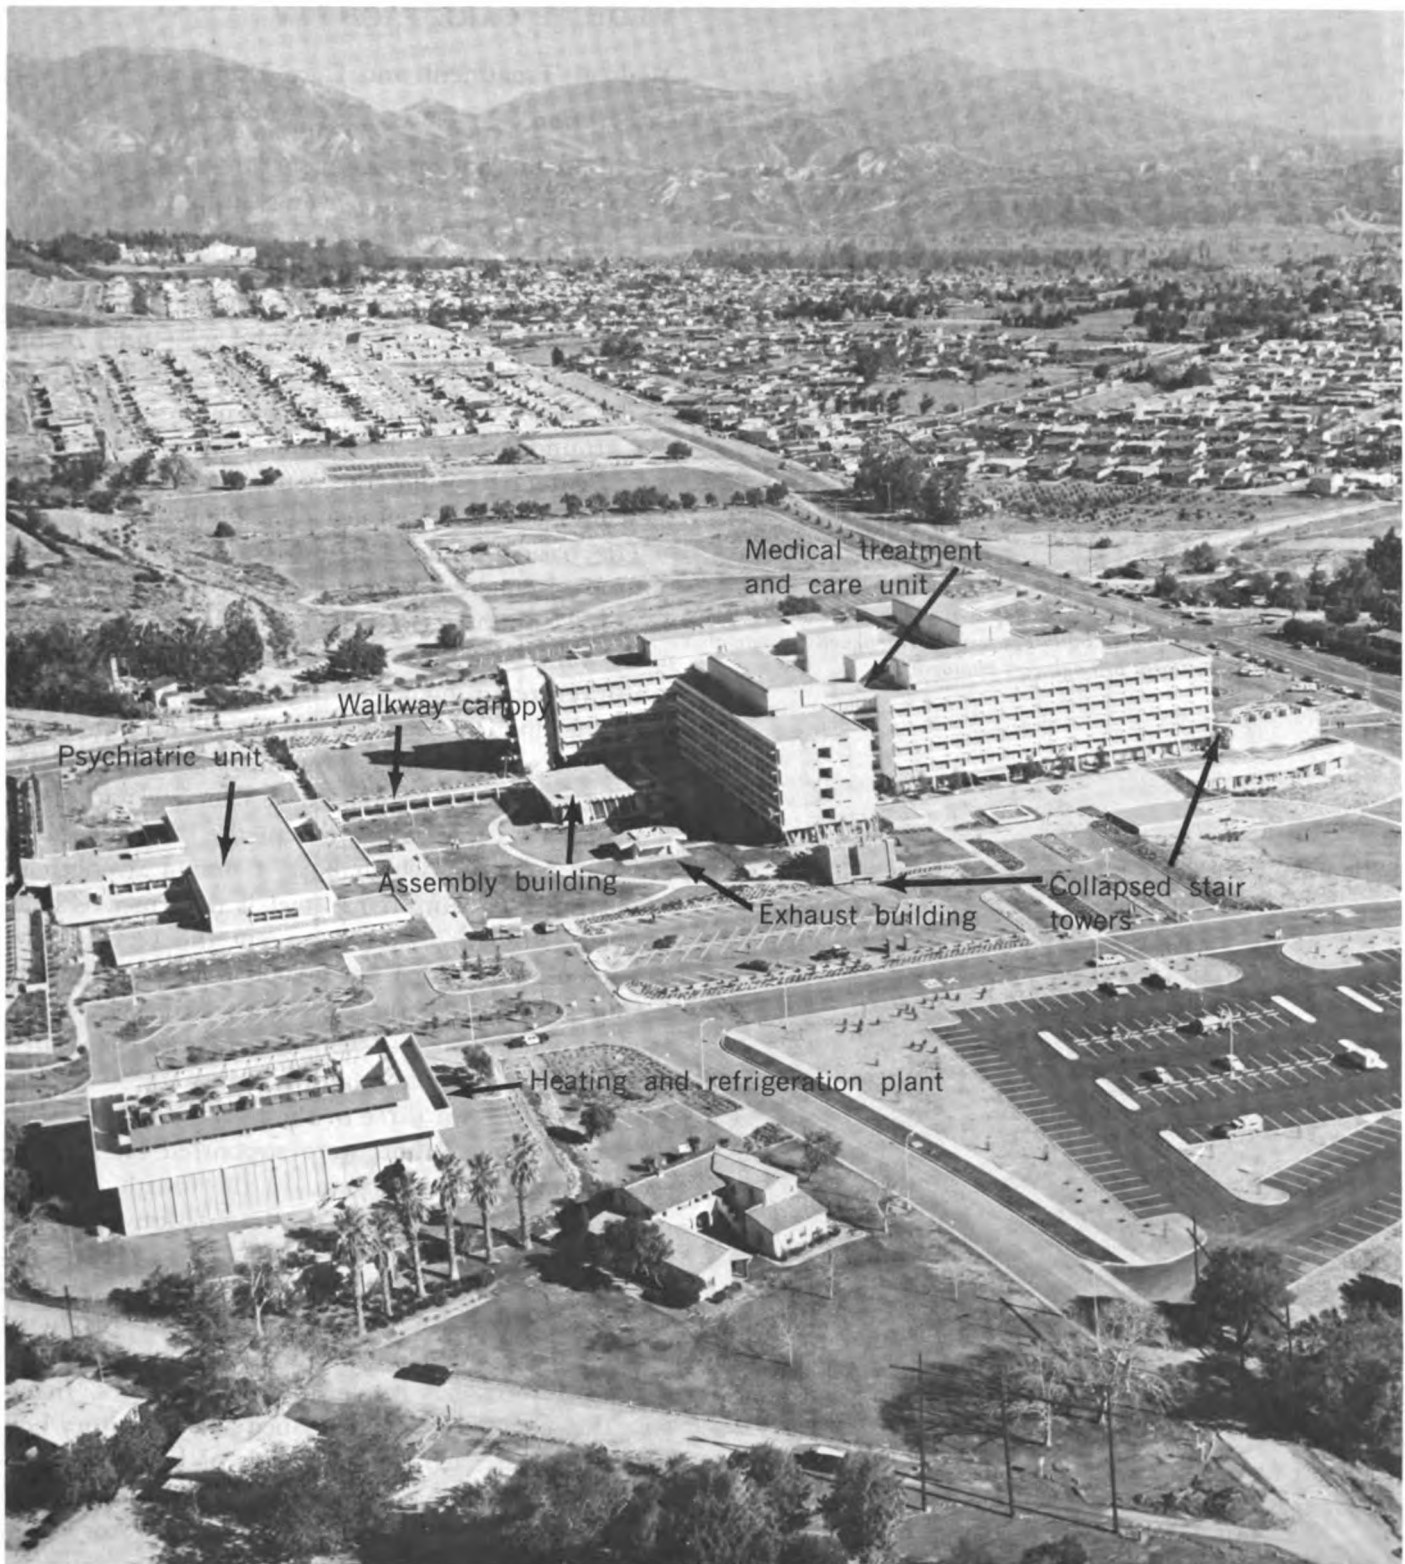
Figure 2.—Olive View Hospital. New hospital complex, looking east. Note overturned stair towers at center and right. Los Angeles City Fire Department photograph.

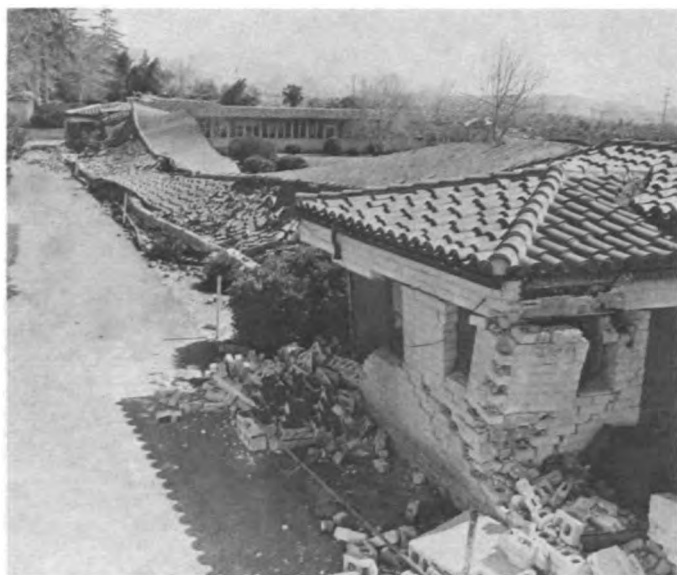
Figure 3.—Olive View Hospital. Collapse of old portion of hospital convalescent wings. These buildings were not designed for lateral loads. U.S. Army Corps of Engineers photograph.

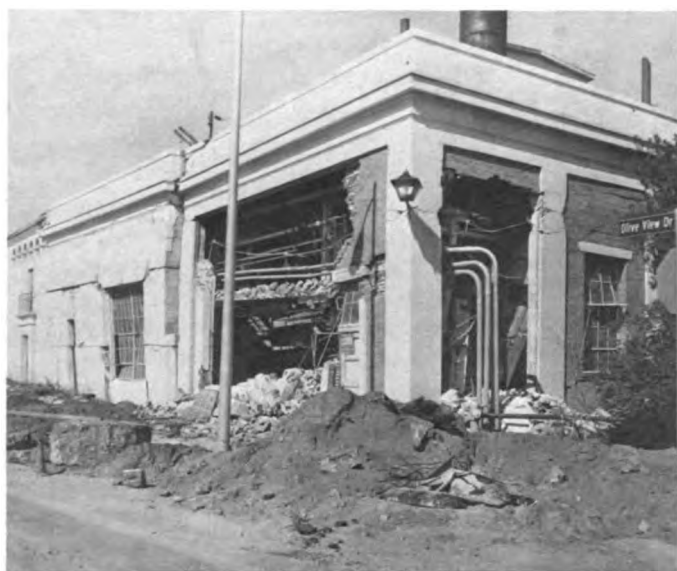
Figure 4.—Olive View Hospital. Damage to old powerplant of hospital. This building was not designed for lateral loads. U.S. Army Corps of Engineers photograph.

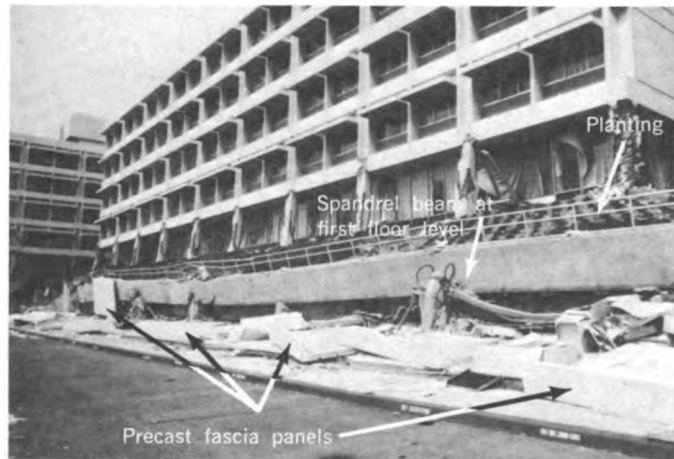
The most obvious distress observed is the distortion in the column from the first to the second floor (figs. 12, 13, and 14). This displacement in a clear height of 14 feet is at the northwest corner, 28 inches toward the north and 15 inches toward the east; at the northeast corner, 15 inches toward the

Figure 12.—Olive View Hospital, medical treatment and care unit. View of south side, looking west, from ground-floor level. Note collapsed ground-floor roof, which is covered by planting, and loss of precast fascia panels from roof spandrel.

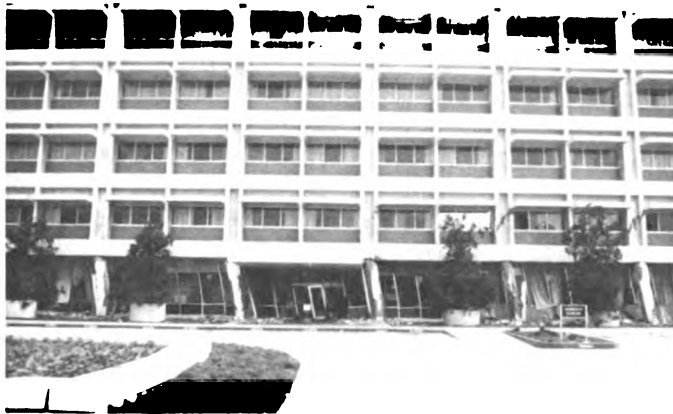
Figure 13.—Olive View Hospital, medical treatment and care unit. View of west side at main entrance from first-floor level.

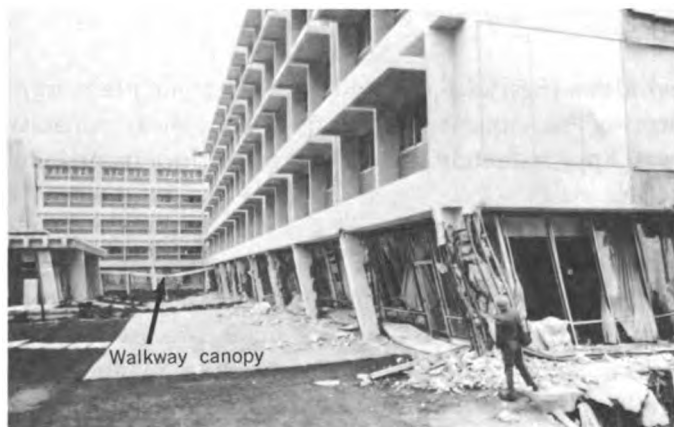
Figure 14.—Olive View Hospital, medical treatment and care unit. View of north side, looking east, from first-floor level. Floor slope is result of collapsed columns below and is emphasized by walkway canopy in background.

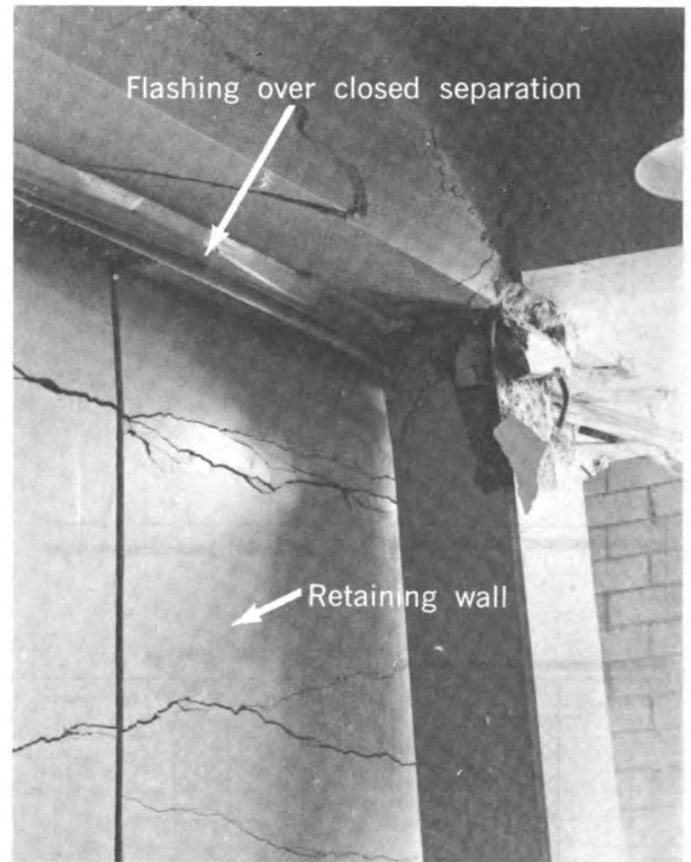
the building moved, closing the minimal 4-inch separation between the resisting frames and the retaining walls, there was an uncalculated, yet effective, resistance developed by these walls. The pounding of the structure against these walls not only disturbed the soil behind the wall, but also caused tension cracks on the inside face (compression side) of the cantilever retaining walls (figs. 15 and 16). It is estimated

Figure 15.—Olive View Hospital, medical treatment and care unit. Horizontal cracks in north basement wall in ground-floor story. Note closure of separation at top of wall.

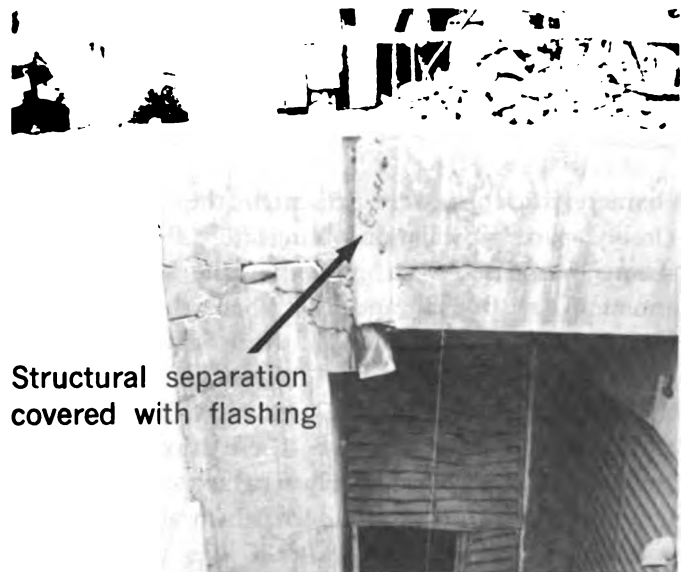
Figure 16.—Olive View Hospital, medical treatment and care unit. Areaway pier at northeast wing, showing effects of hammering by first-floor framing through wall separation.

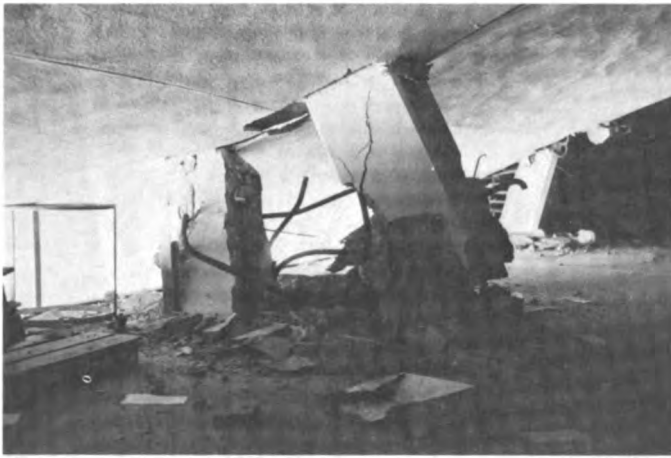
There was failure of all of the tied columns located principally in the base structure (fig. 17) outside the area supporting the four five-story towers.

Figure 17.—Olive View Hospital, medical treatment and care unit. Complete collapse of tied column located at ground-floor level loading dock at east side.

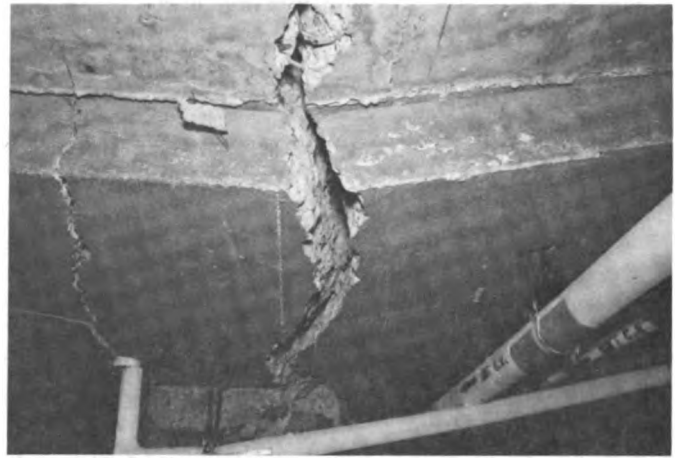
Figure 20.—Olive View Hospital, medical treatment and care unit. Closeup view of figure 19, showing lack of bottom reinforcing bars through crack.

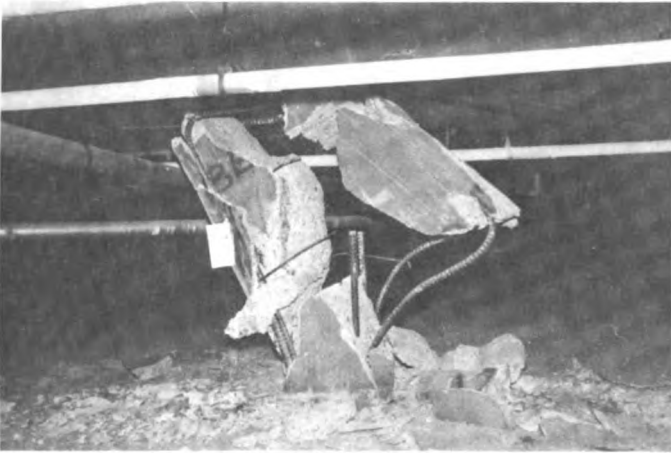
umns located in the pipe space near the north basement wall failed (fig. 18); a continuous crack extending east and west occurred in the ground-floor flat slab (fig. 19); a similar-type crack in the beam and slab framing of the first floor also was apparent (figs. 20 and 21). It was evident that all of these members had been subjected to very high shear stresses, and that either the reinforcing steel was insufficient to resist the magnitude of the forces or the reinforcing steel was mislocated or ineffectively spaced to withstand the unpredictable forces generated in the continuous framing. Further evidence of this type of damage occurred in the flat slab drop panels at the column supports. The cracking and spalling of the

Figure 18.—Olive View Hospital, medical treatment and care unit. Complete collapse of tied column located in pipe space area near north wall.

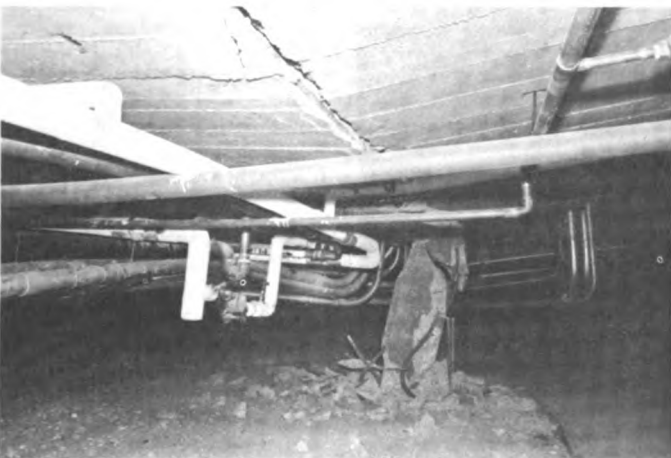
Figure 19.—Olive View Hospital, medical treatment and care unit. Continuous crack formed in underside of ground-floor framing near north wall. Crack is result of collapse of tied columns.

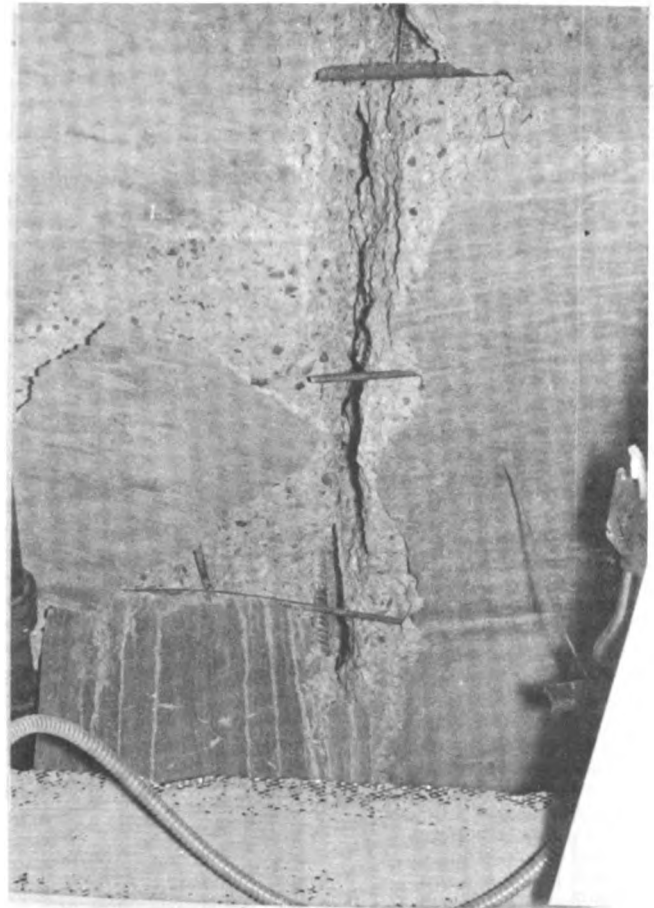
Figure 21.—Olive View Hospital, medical treatment and care unit. Crack formed under first floor framing near a column near the north wall, where column has collapsed below in pipe space.

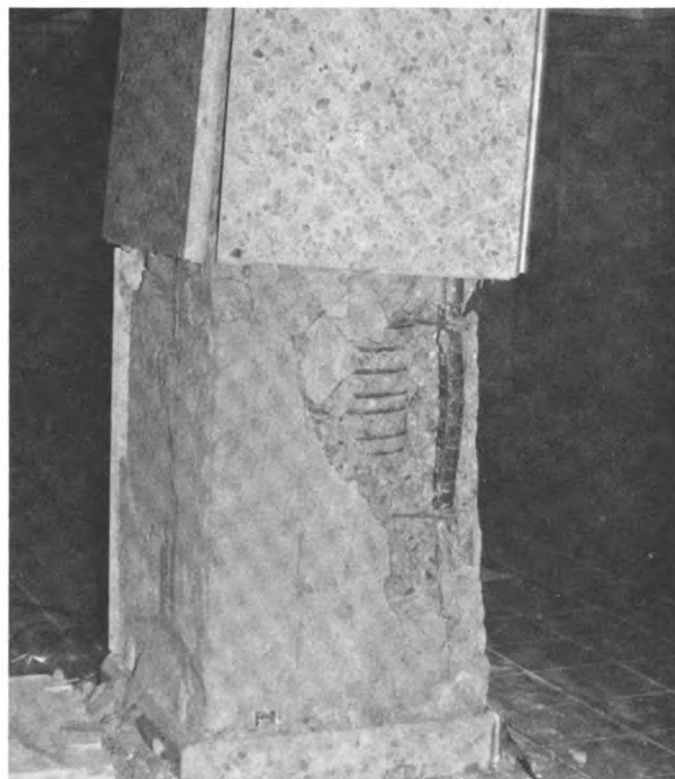
*Figure 23.—Olive View Hospital, medical treatment and care unit. Distortion of column (shown in fig. 22) at first floor.*

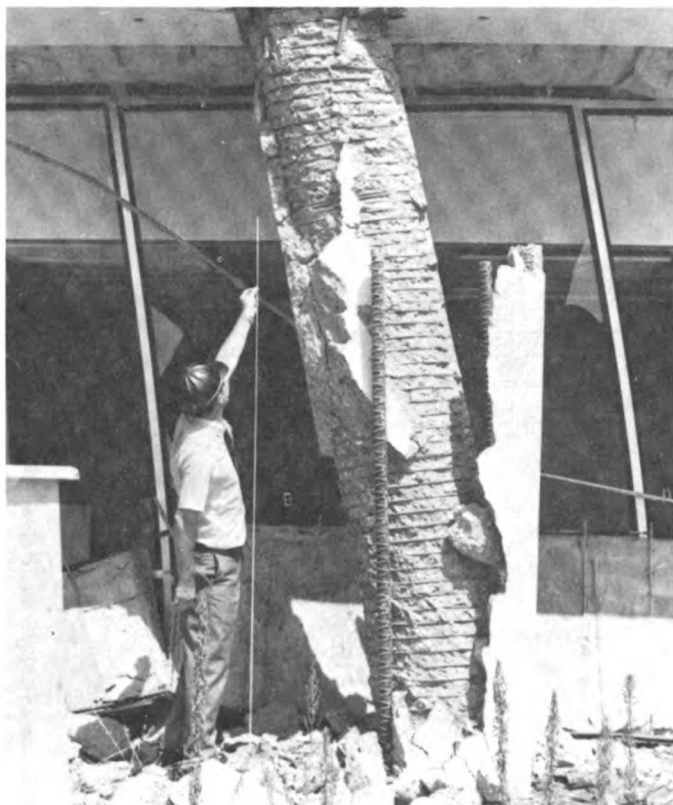
characteristics also were present in the columns with closely spaced spiral reinforcing (figs. 24,E and 25). There was distress in many of the beam-column connections (figs. 26 and 27) where the stirrups or ties did not extend through the joints. Failure occurred in the corner tied columns (figs. 24,E, 28, and 29). Interestingly, the vertical and lateral loads, which caused the collapse of these corner columns, were transferred to the adjacent exterior columns through the cantilever action of the walls above the column (figs. 30 and 31).

Figure 25.—Olive View Hospital, medical treatment and care unit. Distortion of exterior column at first-floor level.

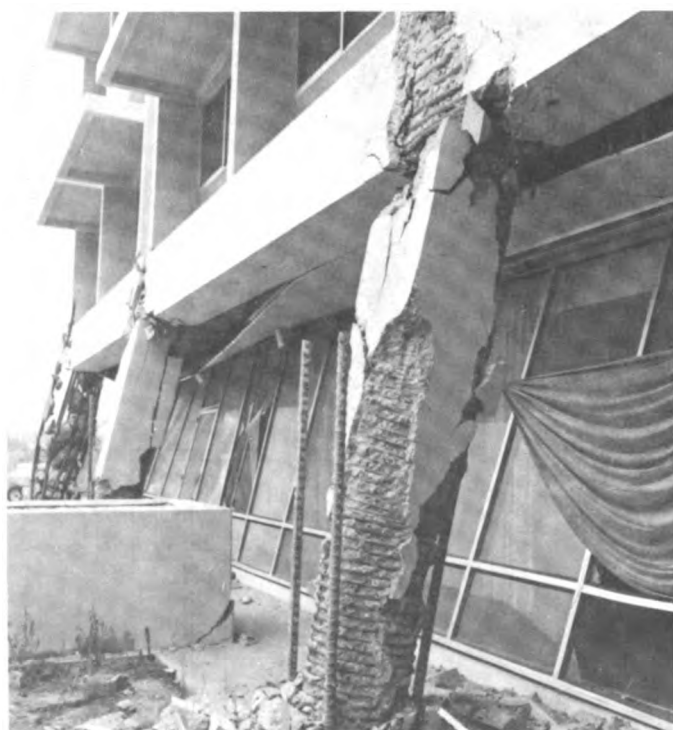
Figure 26.—Olive View Hospital, medical treatment and care unit. Distortion of exterior column at first-floor level.

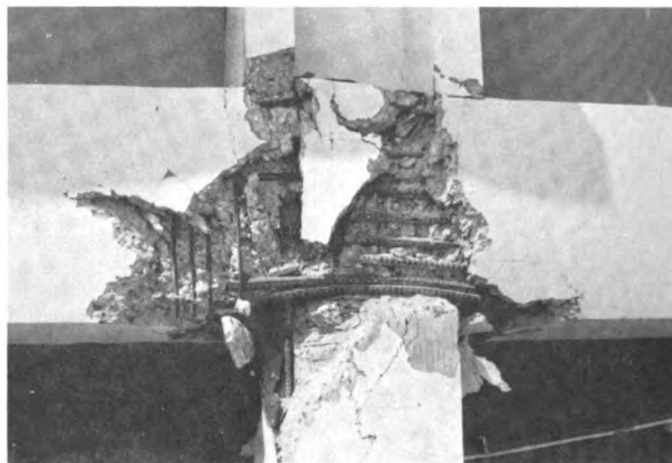
Figure 27.—Olive View Hospital, medical treatment and care unit. Beam-to-column connection detail of figure 26. Note lack of confinement to beam reinforcing bars in this area. Bottom bars also were lapped in this area.

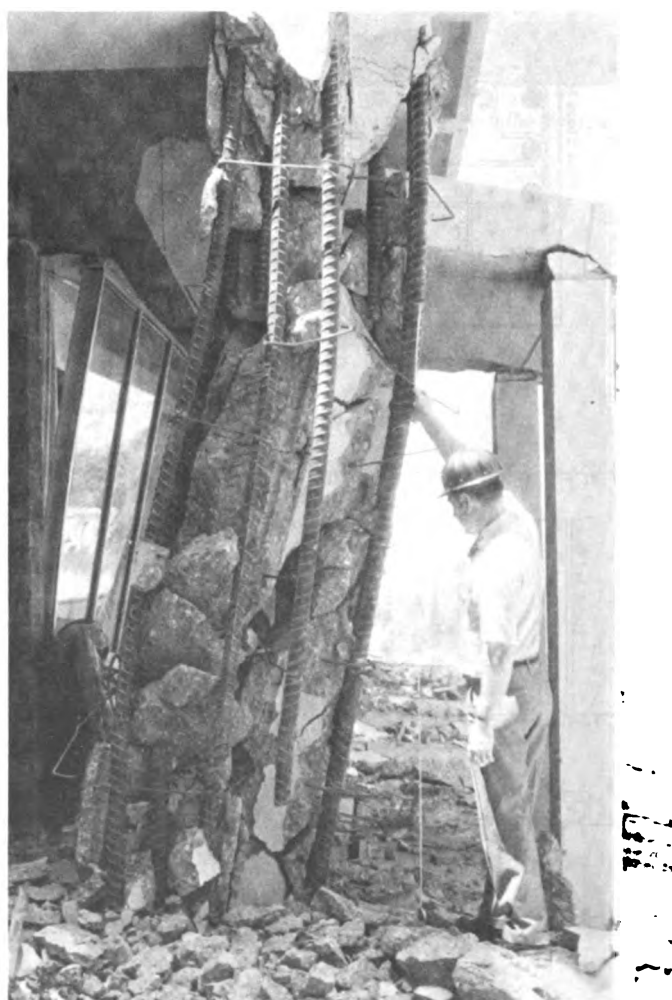
Figure 28.—Olive View Hospital, medical treatment and care unit. Collapse of corner column at first-floor level.
